**CREEP PERFORMANCE  
TEST REPORT**

**TREX COMPANY LLC**

**Seclusions Composite Privacy Fence System  
TYPE: Composite Fence System**

| <b>Report No.:</b> | <b>63565.01-116-20</b> |

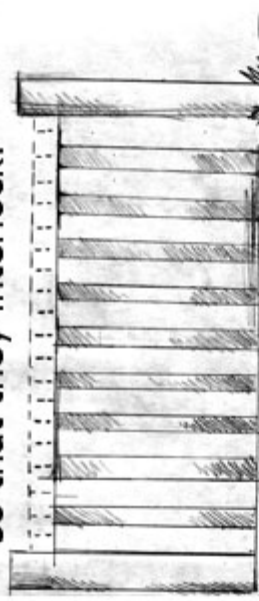
Interlocking Pickets

Alternate their orientation, so that they interlock.
